Firmware Version:
 28: 4.00.012
 52: 4.00.025
 28P: 4.00.043
 20: 4.00.041

These release notes include important information about D-Link switch firmware revisions. Please verify that these release notes are correct for your switch:

Upgrade Instructions:

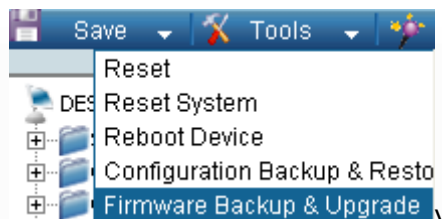
1. Connect a workstation installed with java SE runtime environment to any switch port of the device.
2. Open the web browser from the workstation and enter the IP address of the switch. The switch's default IP address is 10.90.90.90.
3. Enter administrator's password when prompted. The password is **admin** by default.
4. To update switch's firmware or configuration file, select **Tools > Firmware Backup & Upgrade** from the banner.

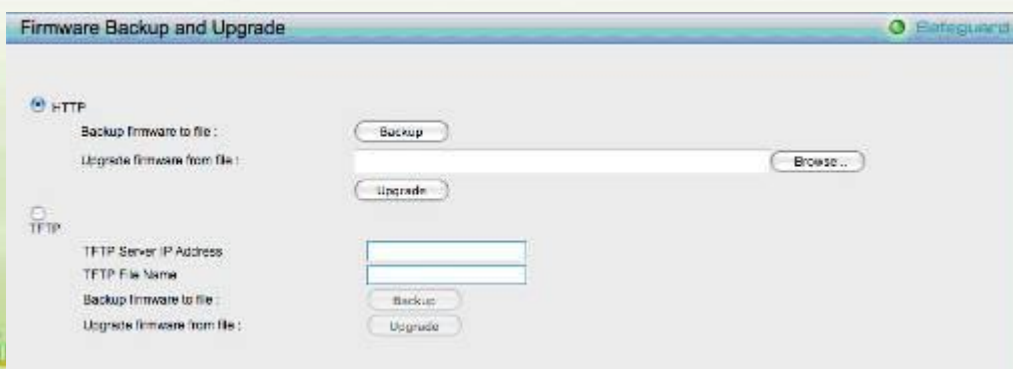
5. Two methods can be selected : **HTTP** or **TFTP**

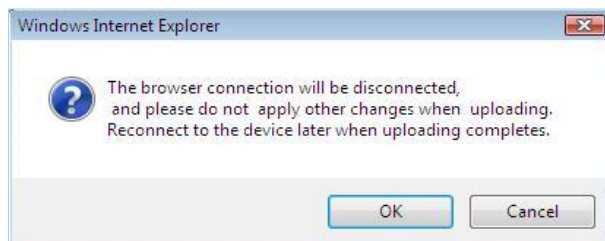
6. Select **HTTP** to upgrade the firmware to or from your local drive of PC.
 - a. Click **Browse** to browse your inventories for a saved firmware file
 - b. Click **Upgrade** after selecting the firmware file you want to restore
 - c. Click **OK** to continue with firmware upgrade

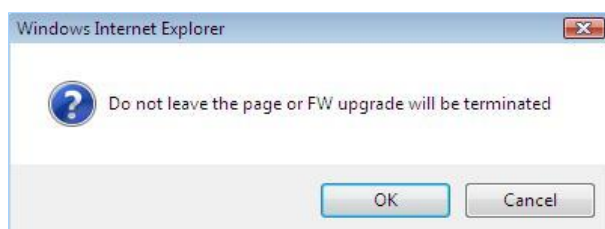
- d. Click **OK** to continue with firmware upgrade

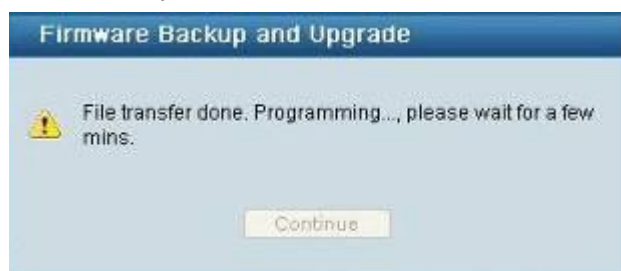
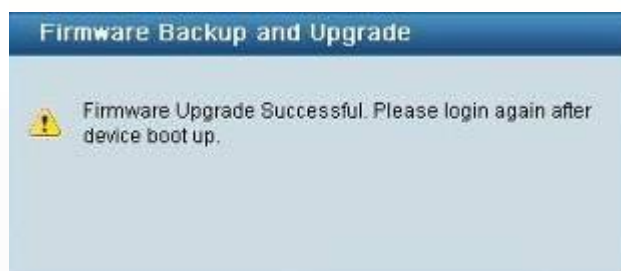
- e. Wait until the "Firmware Upgrade Successful" message pops up and login again after device boots up.

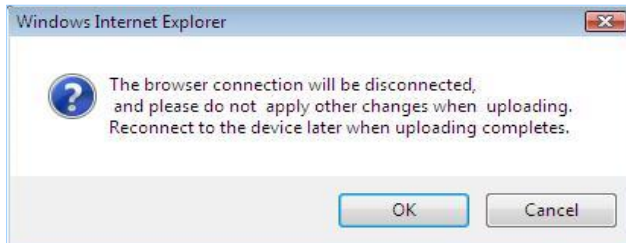
7. Select **TFTP** to upgrade the firmware to or from a remote TFTP server.
 - a. Enter the name of the firmware file located on the TFTP server
 - b. Click **Upgrade** after selecting the firmware file you want to restore
 - c. Click **OK** to continue with firmware upgrade

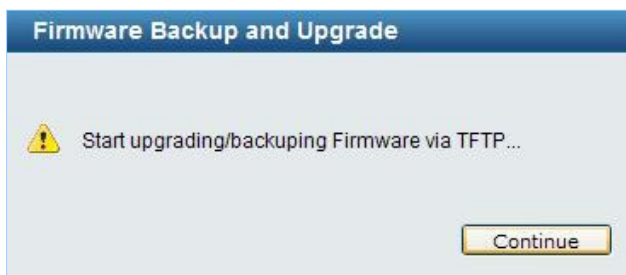
- d. Wait until the firmware upgrade ends and login again after device boots up.

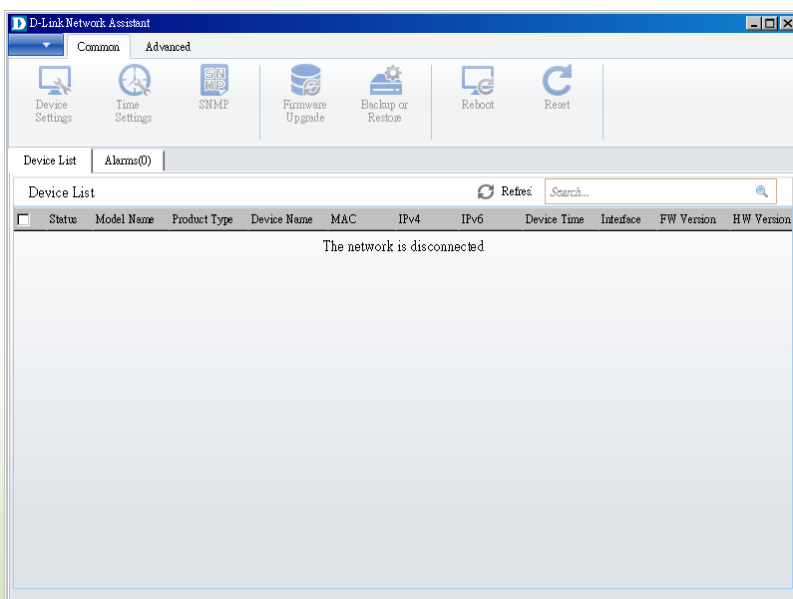
1. Connect a workstation installed with java SE runtime environment to any switch port of the device
2. Execute D-Link Network Assistant

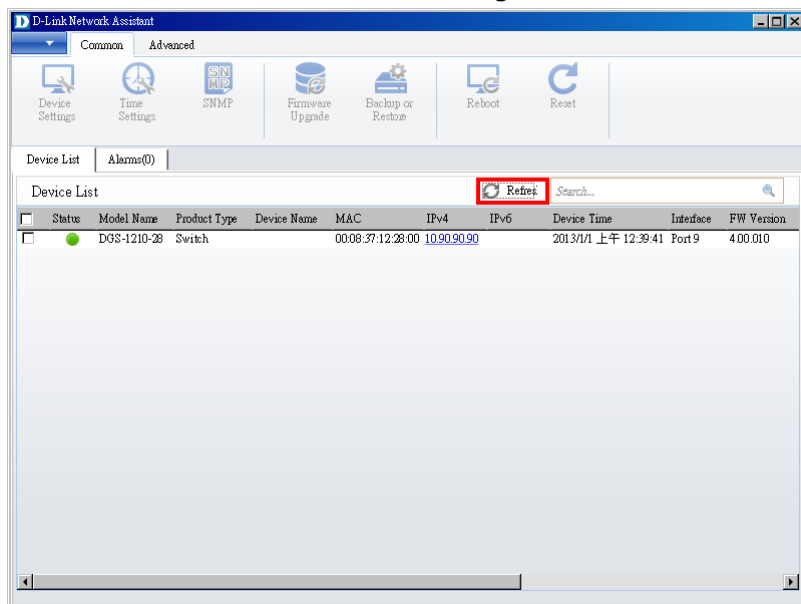
3. Click Refresh button to search target switch

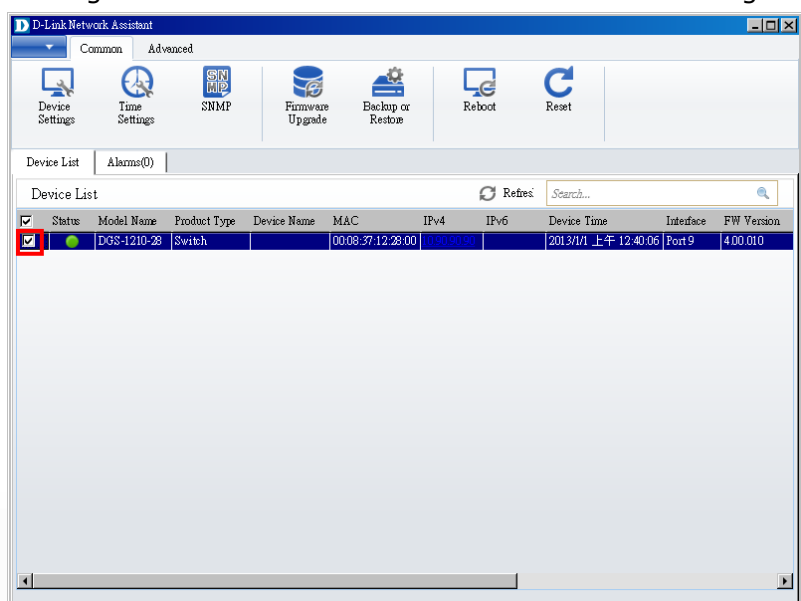
4. Single click the icon of the column to choose the target switch

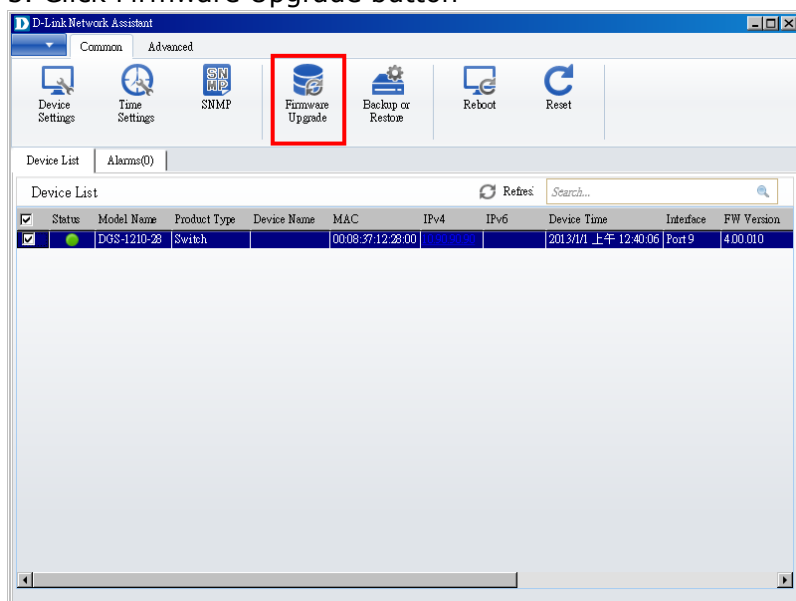
5. Click Firmware Upgrade button

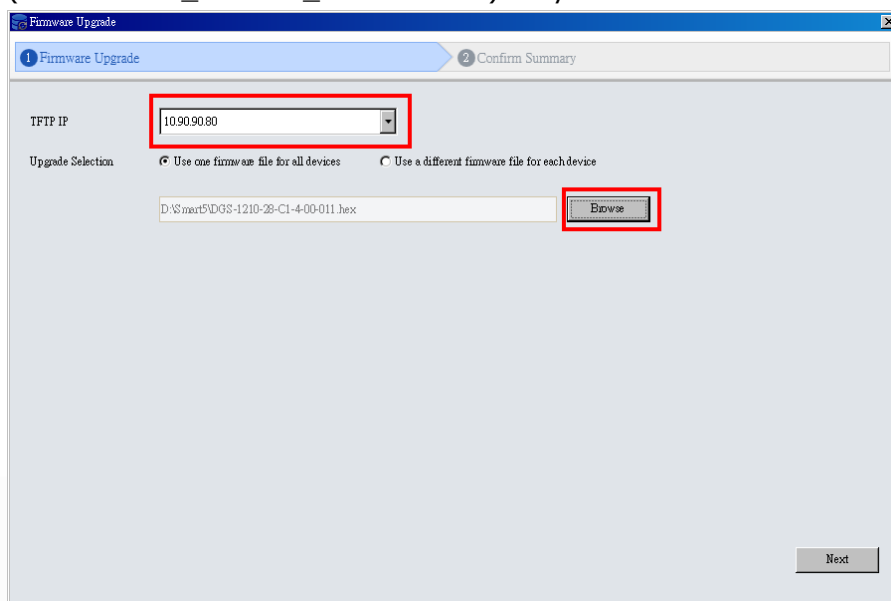
6. Select PC IP address of the target switch, then click Browse button and select the firmware file (Model name_HW ver._FW ver. .hex) on your local hard drive.
